## How did we get here....

## Archaeological investigations – ancient trackways and neolithic reedbeds

## Restoration works – deep trench bunding, and deep water...

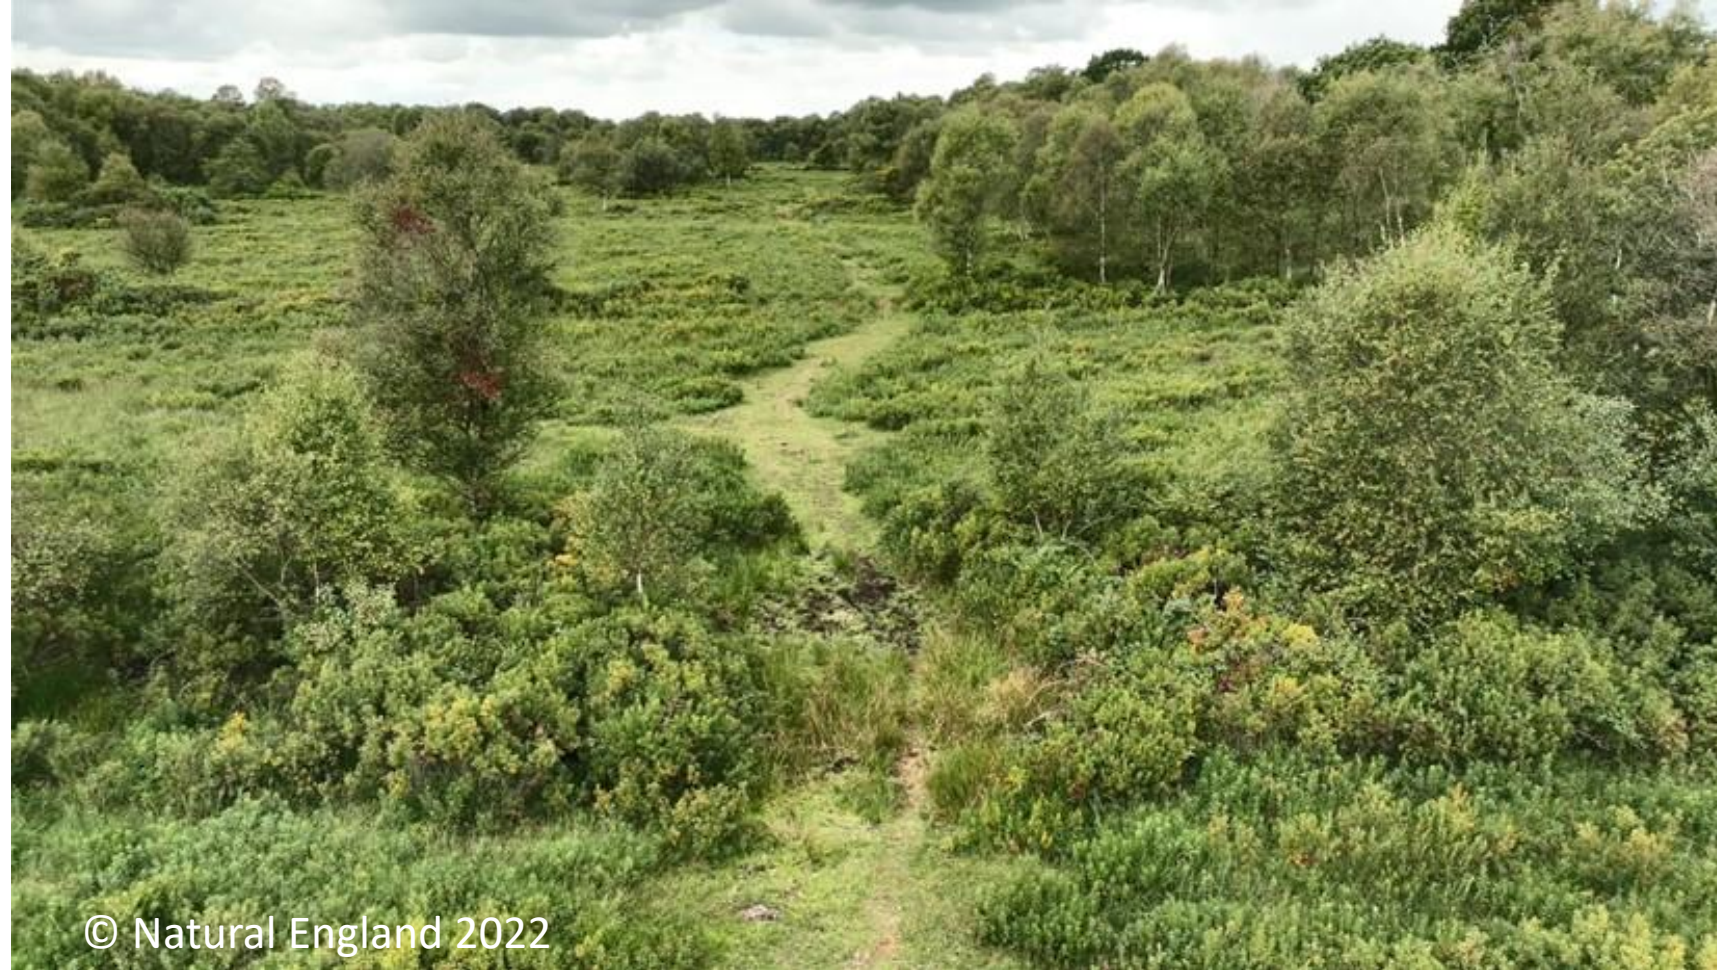
Left: before, dominated by bog myrtle and birch scrub

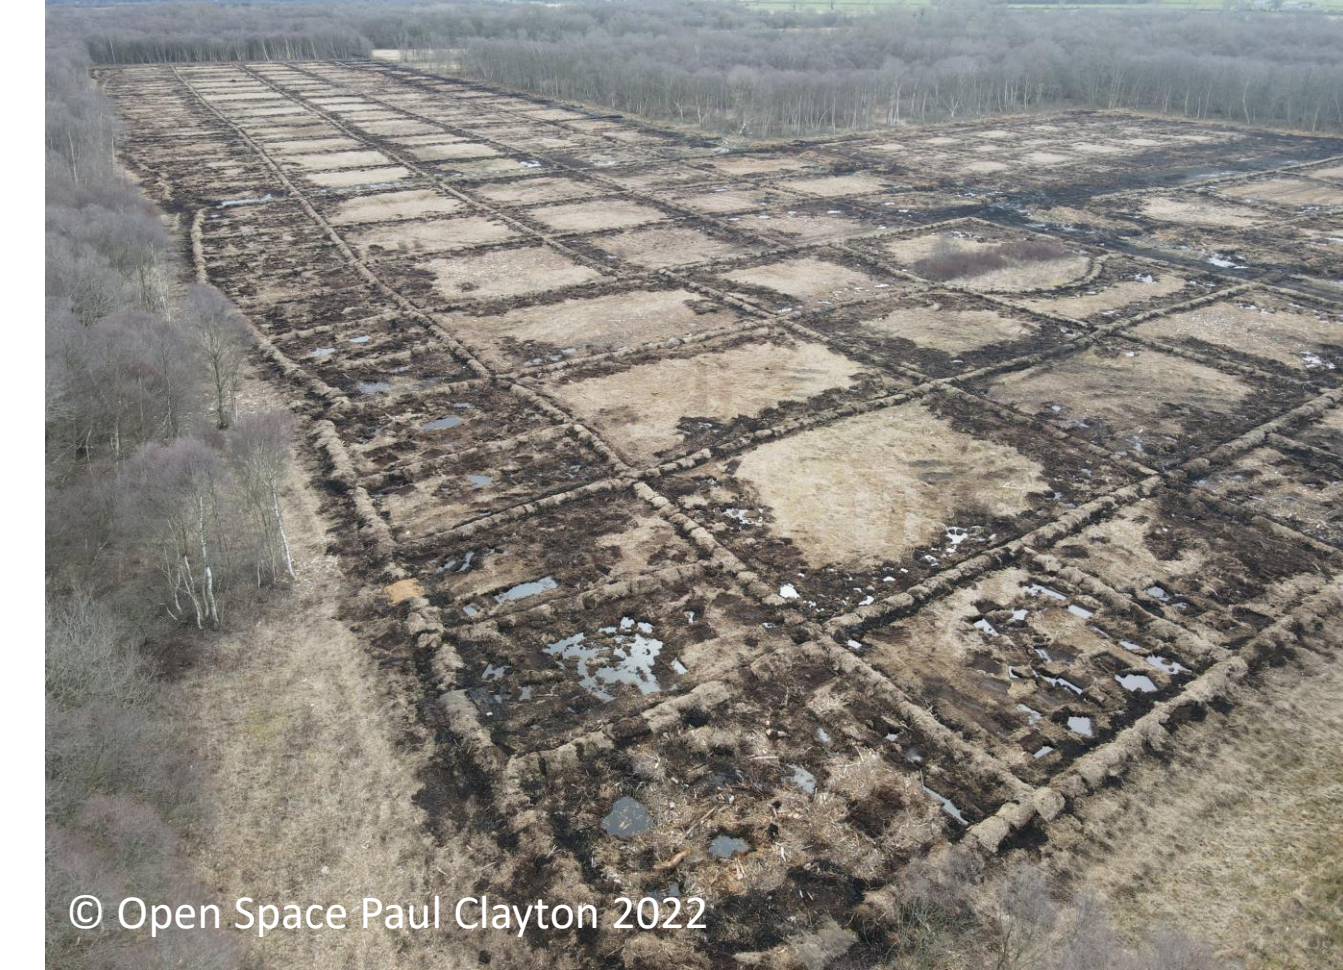
Right: Immediately after trench bunding works completed

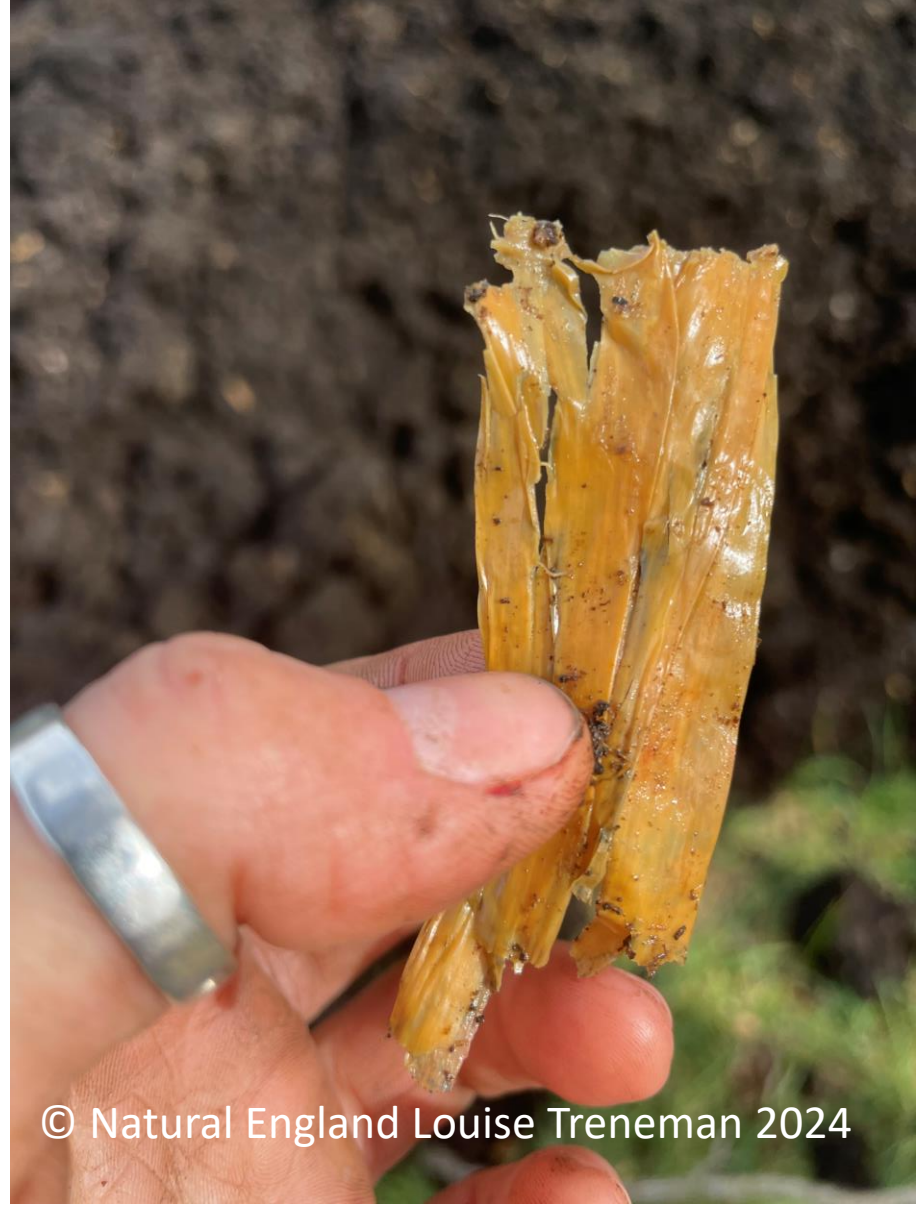
Left: Reed fragment found in the test pits, probably neolithic age.

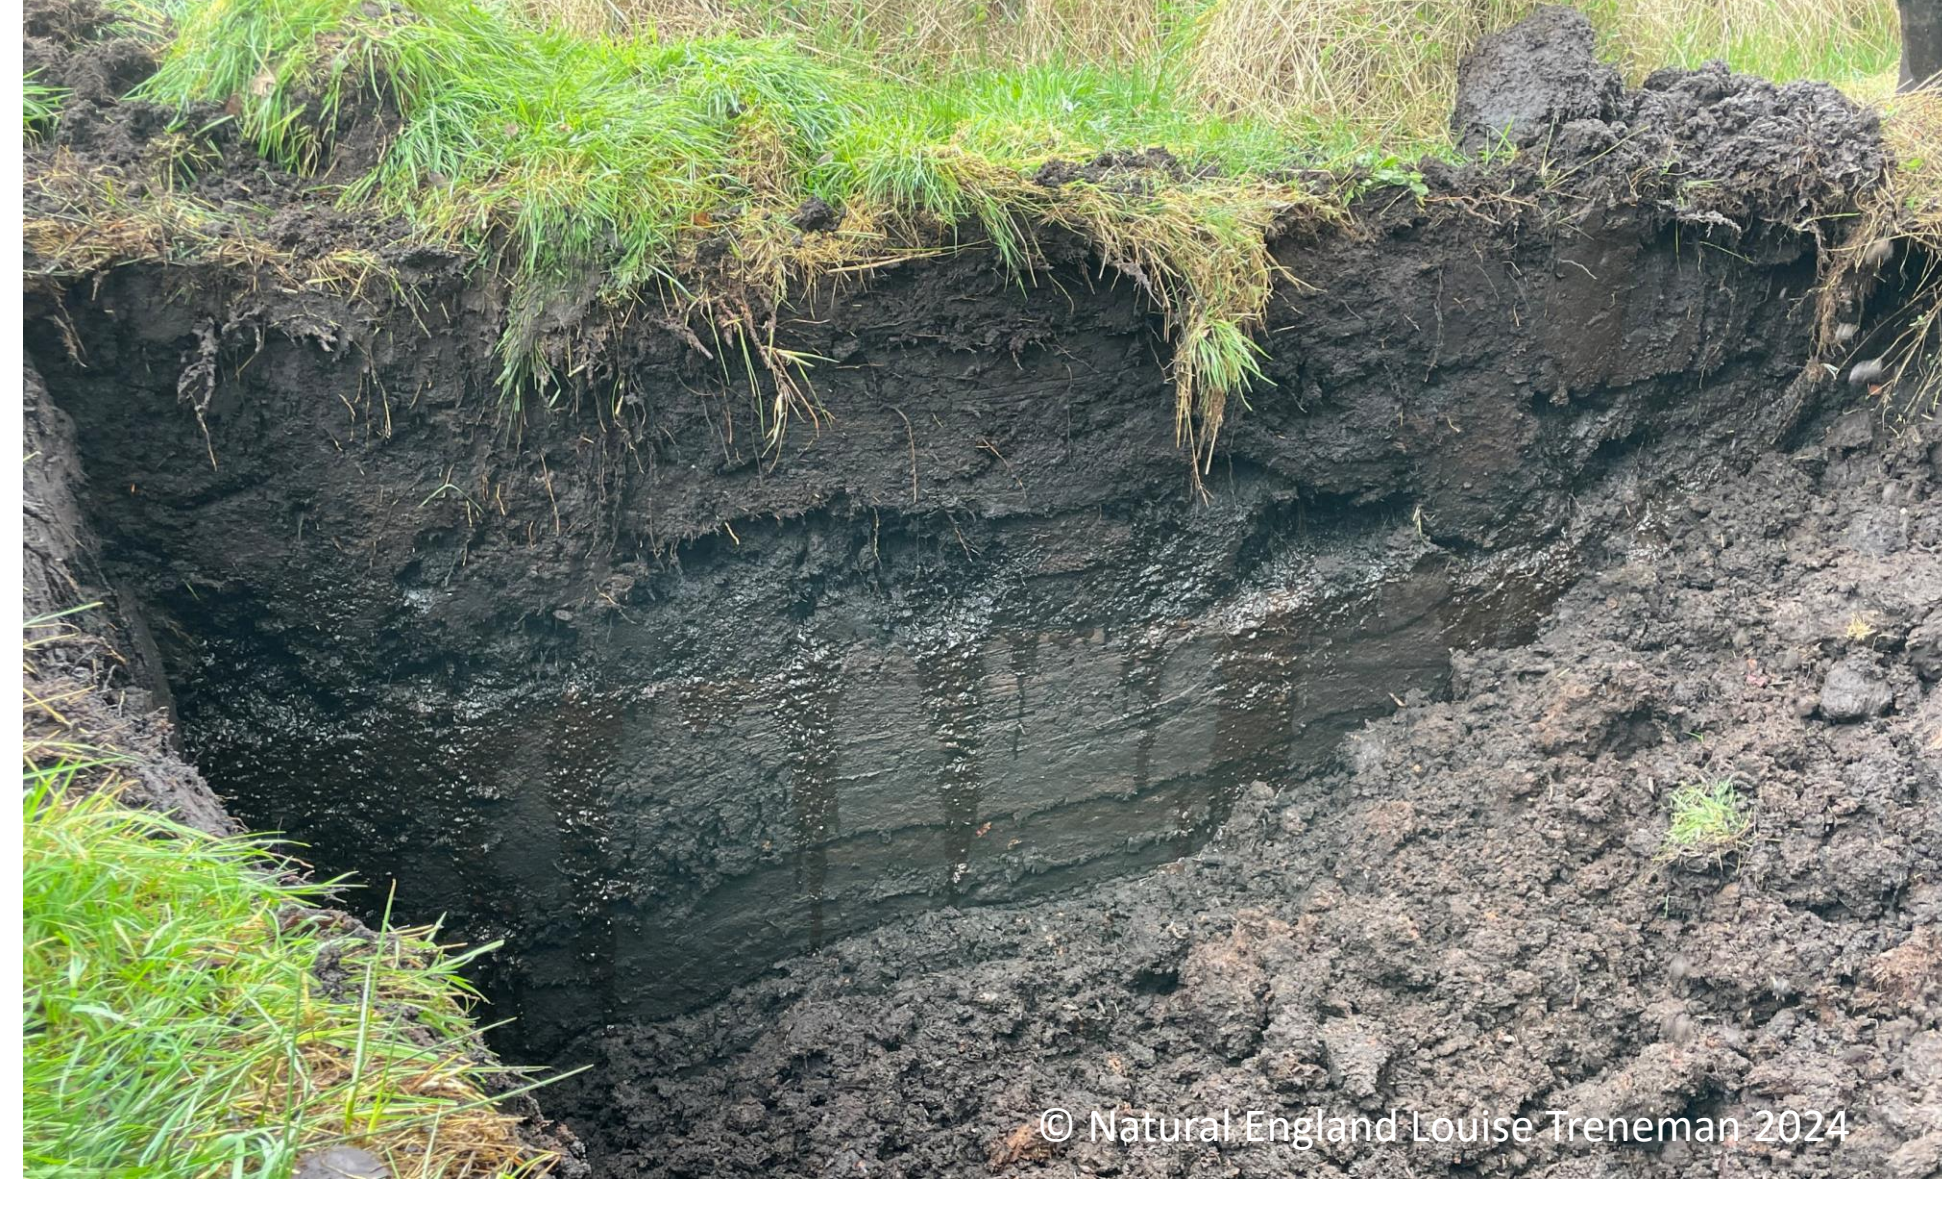
Right: subsurface seepage line – why we need deep trench bunds!

Once the idea of restoring these areas to their full boggy potential had taken root, there was the question of what techniques to employ. We'd tried blocking ditch ends, holding sluices higher, volunteers cutting scrub for weeks at a time, all to no avail. Learning from projects up in Cumbria, deep trench bunding was decided on as the best way to fix the leaky hydrology. Those who had worked on the Somerset Levels were sceptical at first, as these techniques seem very disruptive, but after a field trip up north to see the successes, everyone was on board! We dug test pits to investigate peat condition and to identify the depths of cracks and peat pipes. This then informed the depth of the trench bunds.

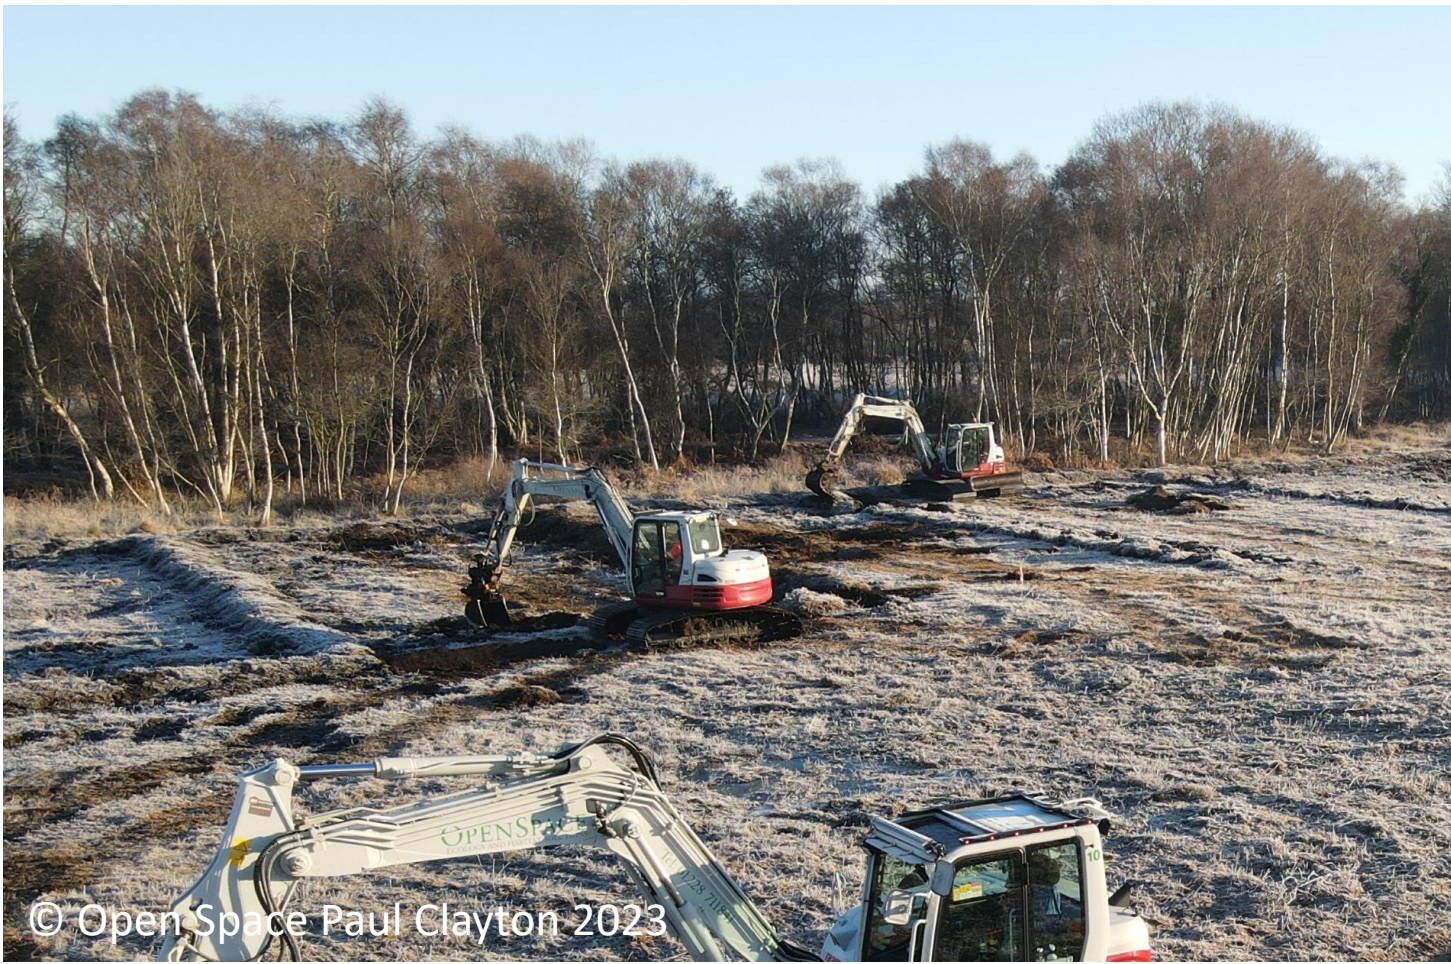
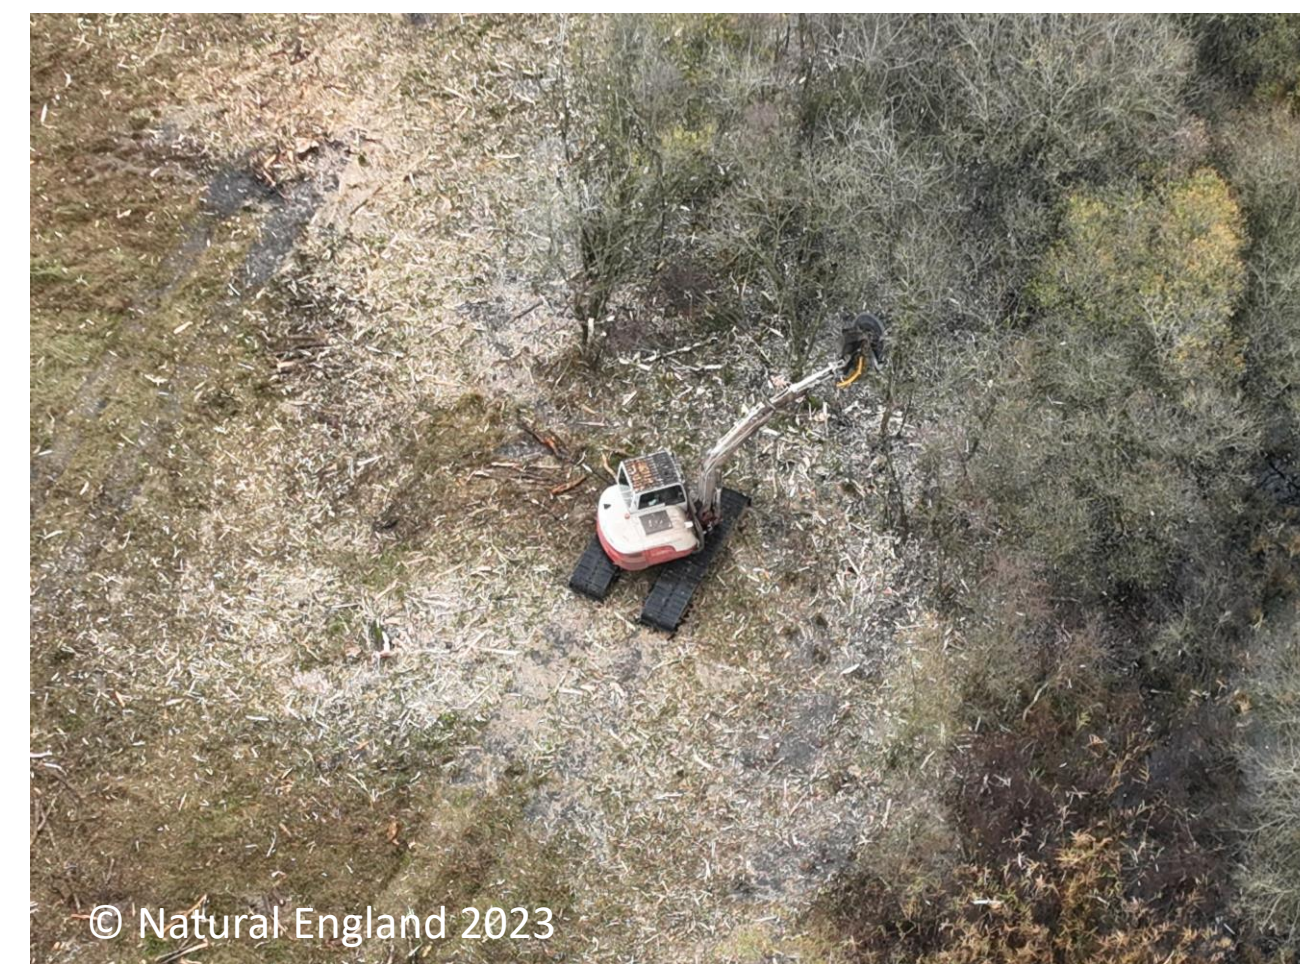
Trench bunding and tree mulching in action!

It is worth mentioning this work took place over 3 winters, with only the final phase (to be completed this winter) having the added complication of scaly creatures... The first phase of works was completed in February 2023, during a very dry post-Christmas period which made for very easy work. Trees and scrub were mulching with an excavator mounted mulching head, and then deep trench bunds were installed to seal up subsurface cracks in the peat using low ground pressure diggers. Phase 2, completed February 2024, was not to be so easy. It rained and rained and rained some more, a digger went down in the bog, and gate ways became impassable.... But all was not lost, and our trusty contractors Open Space persevered and got the works done despite all the set backs.
